Principle Spillway Investigation

November 2016

Project Background

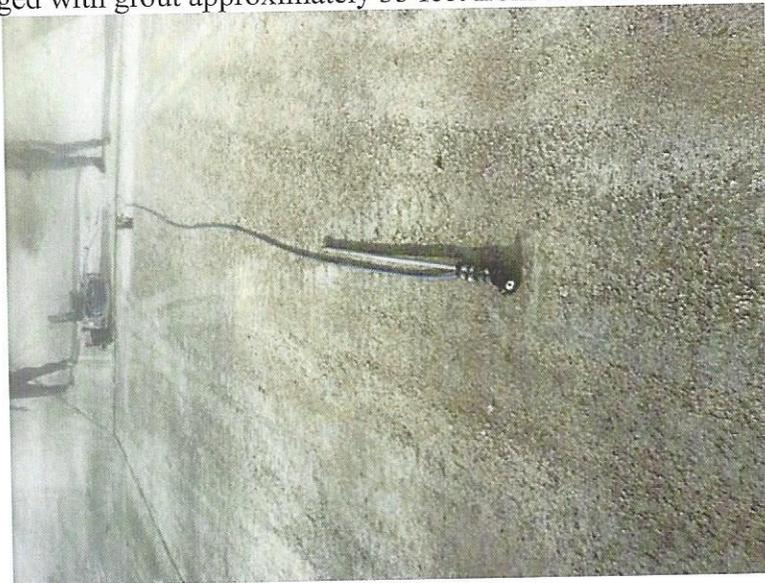
1. The pipe was plugged with grout approximately 35 feet from the base.

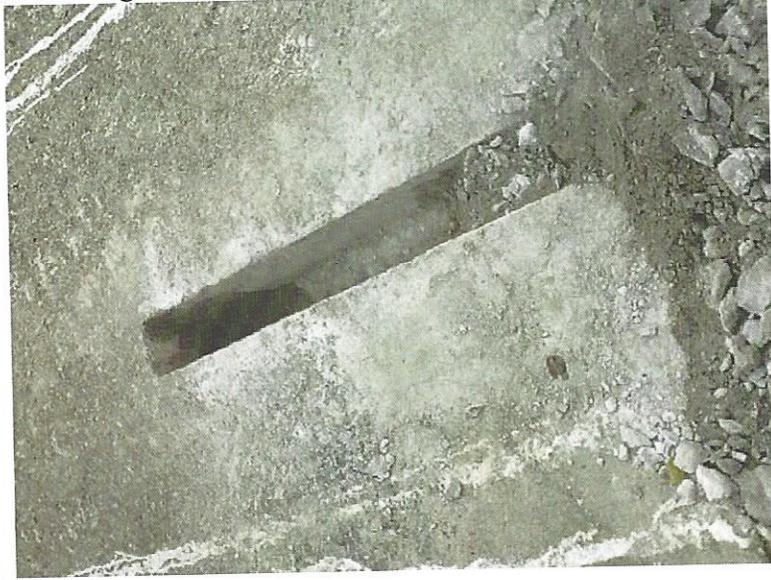
2. The pipe was plugged at the outlet with grout. The grout was removed from the outlet with a jack hammer. The investigation showed the pipe was plugged inside with grout.

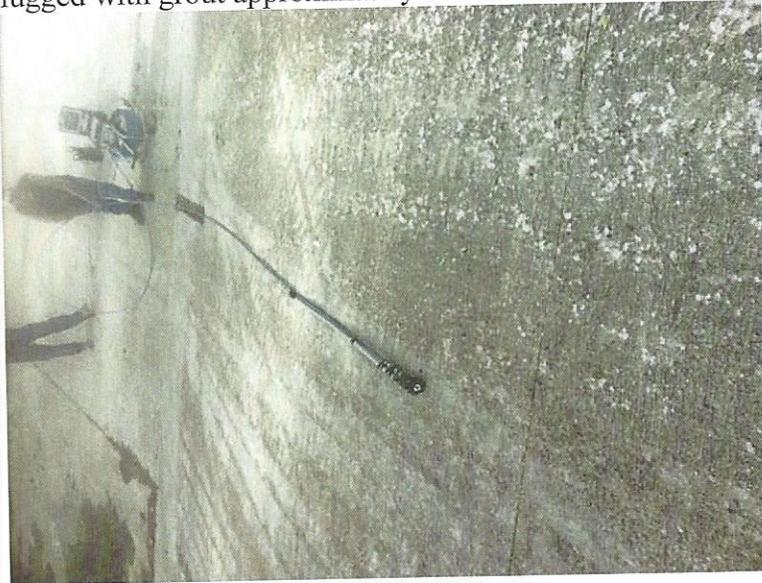
3. The pipe was plugged with grout approximately 17 feet from the base.

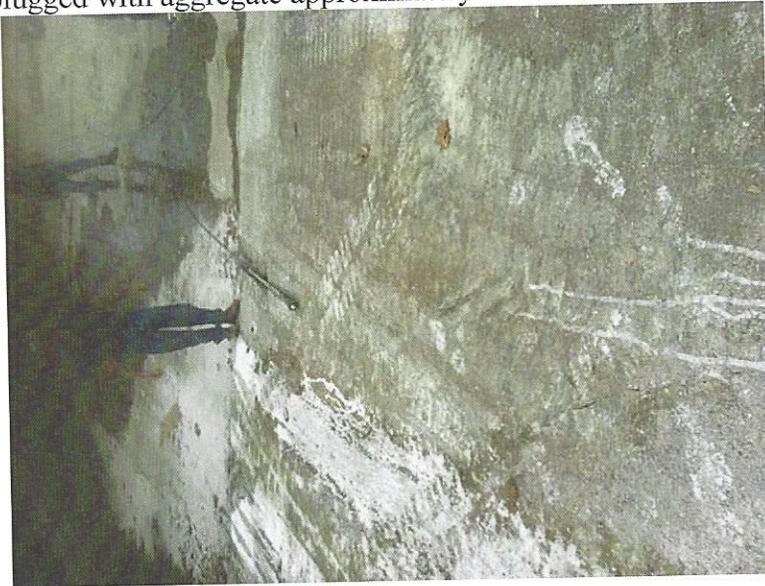
4. The pipe was plugged with aggregate approximately 7 feet from the base.

It is apparent that none of the main drain pipes were functioning as intended when designed and installed.

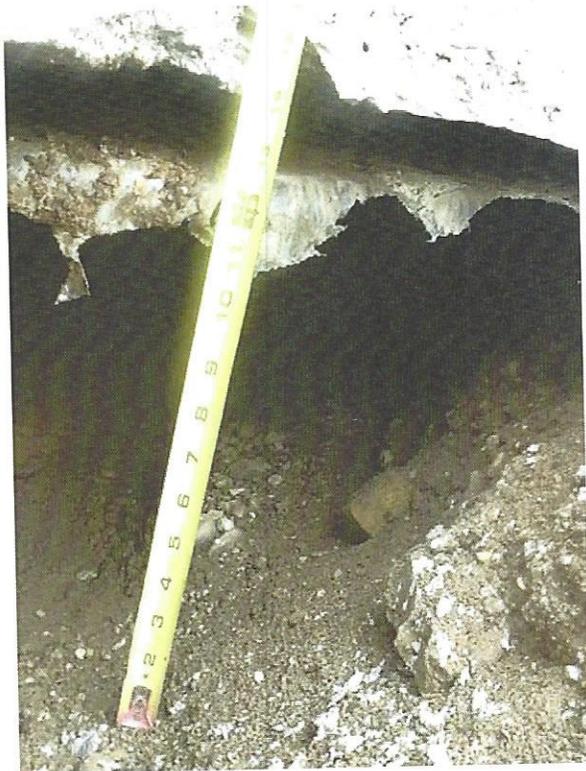
Hole 1 was located just north of the drawdown valve about 14 feet from the headwall (See investigation layout in Appendix A). The void was noted to be 14 inches or greater at this location. A drain pipe was observed within the hole. The subsurface drain pipe is corrugated metal pipe with spiral corrugations. The void was measured using a tape measure. When measured it was evident, the void went all the way to the head wall. The headwall was observed and a failure in the joint sealant was found.

Investigation Hole #1
14 inch Void towards Headwall

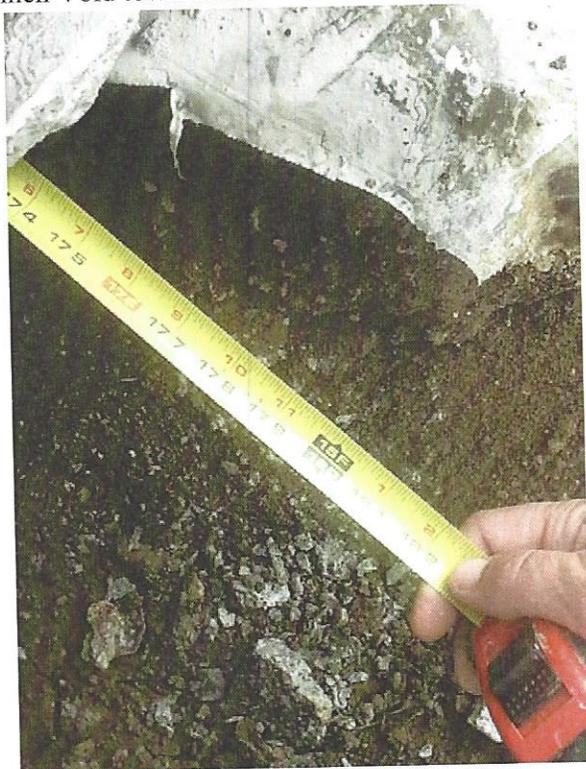
Investigation Hole #1
14.5 foot Void to Headwall

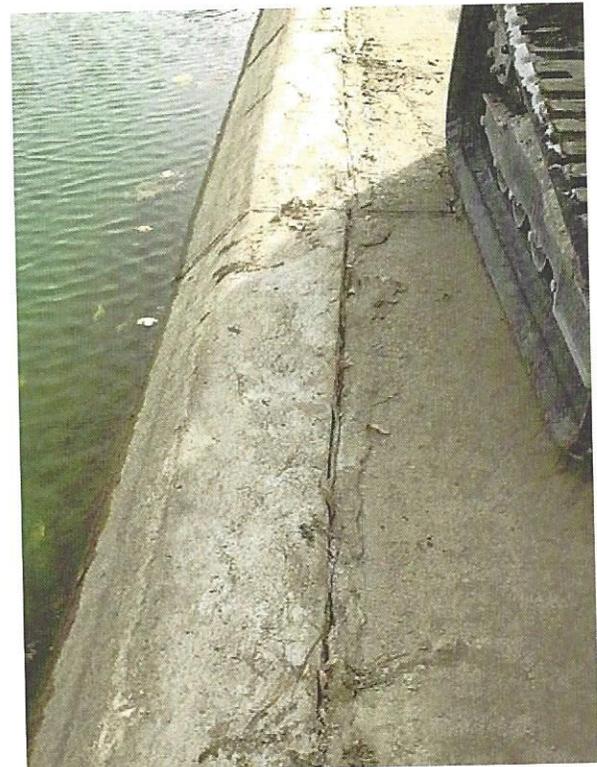
Joint Seal upstream of Hole #1
Failed Crack Seal where Water Enters System 14.5 feet
from Investigation Hole #1

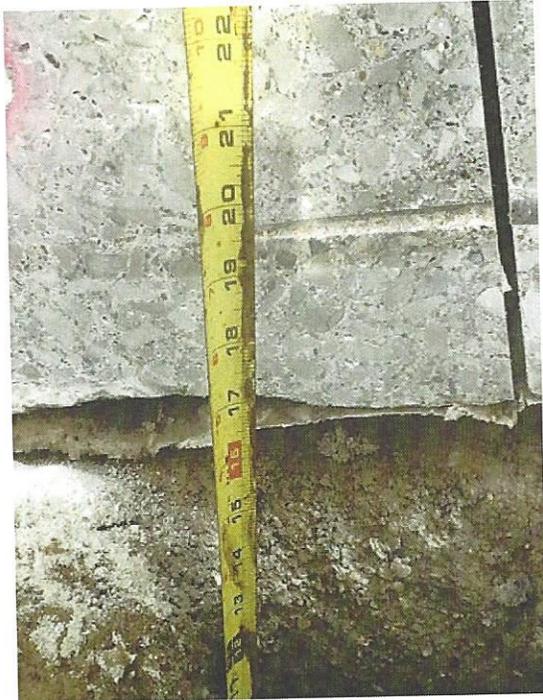
Hole 2 is located approximately 20 feet down the slope from Hole 1. It is located further south of hole #1 and is adjacent to a primary drawdown drain pipe. Additionally, this location exposed a lateral drain connection. A 17 inch void was noted at this location. Lastly, it was observed that the perforations in the existing pipes are large enough to allow base material to be carried out with running water.

Investigation Hole #2
17 inch void

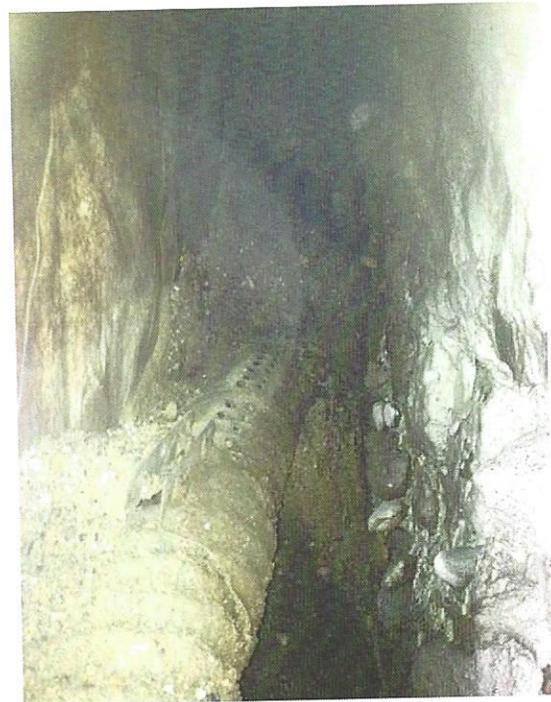
Investigation Hole #2
Large perforations observed in drain pipes

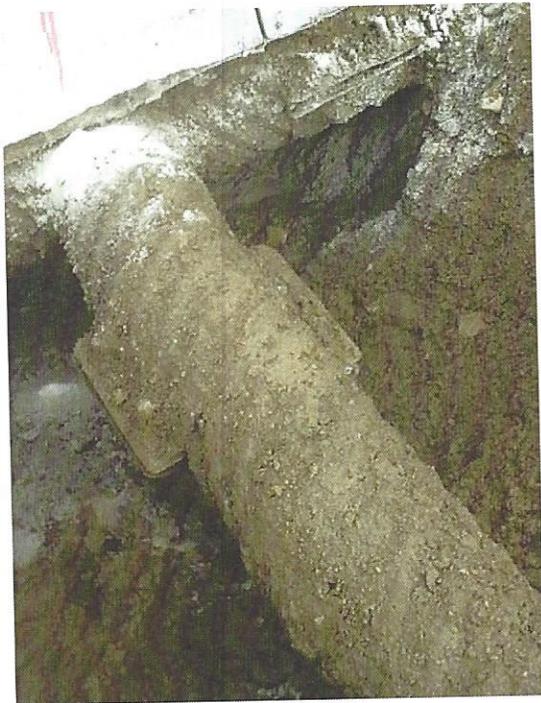
Lateral Drain in Hole #2

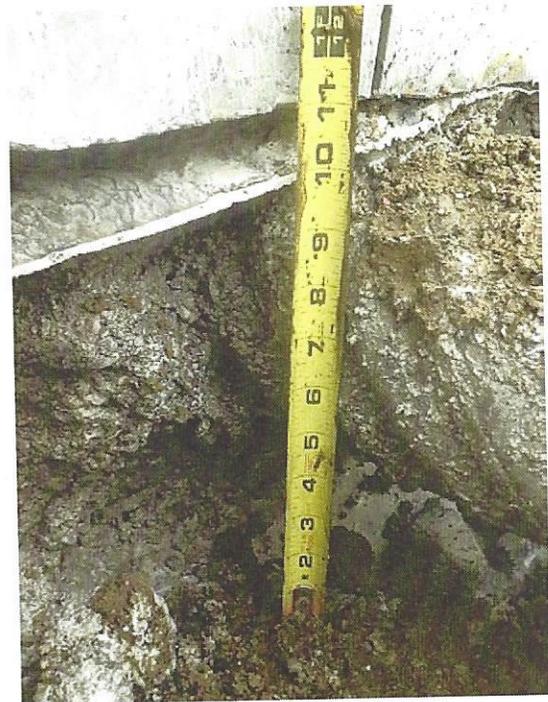
Investigation Hole #2
11 inch Void at Main Drain Pipe

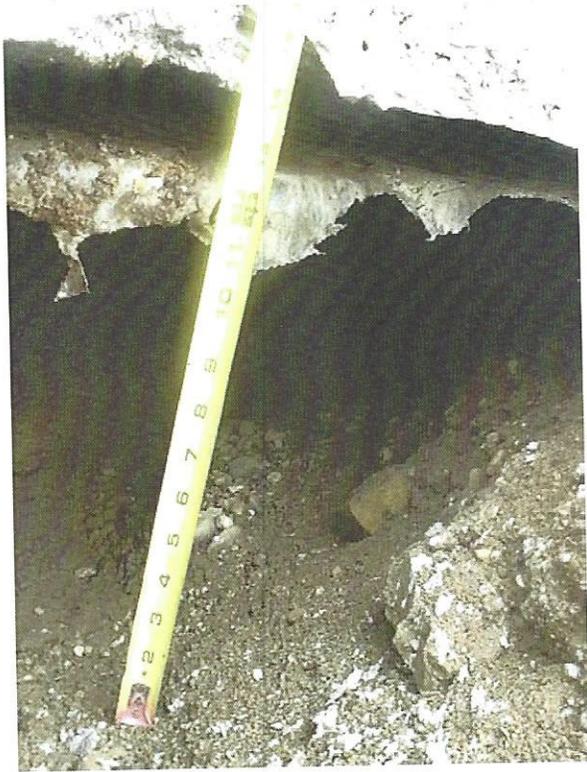
Hole 3 was located approximately 50 feet down the slope from Hole 2. A primary drain pipe is located on the north side of Hole 3. A 14 inch void was noted at this location. Remnants of previous grouting operations were noted within this hole.

Inspection Hole #3
14 inch Void

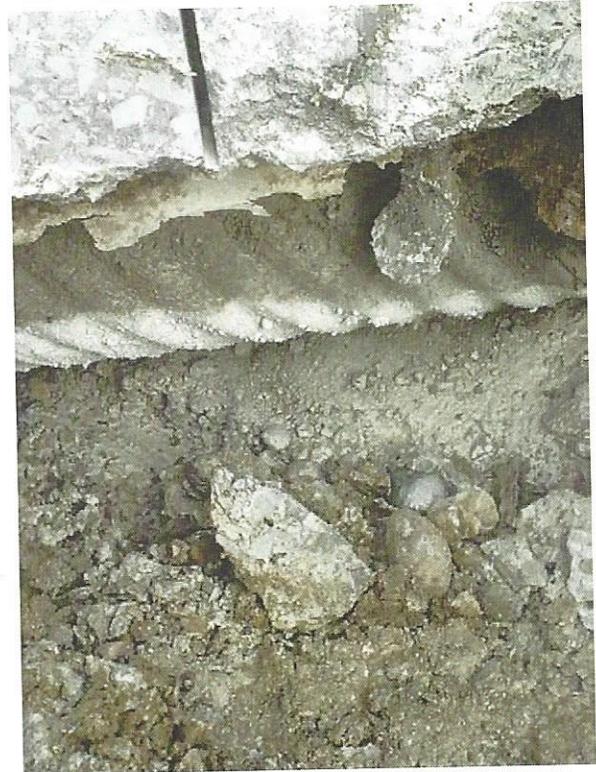
Inspection Hole #3
Drain Pipe Lateral (note apparent grout)

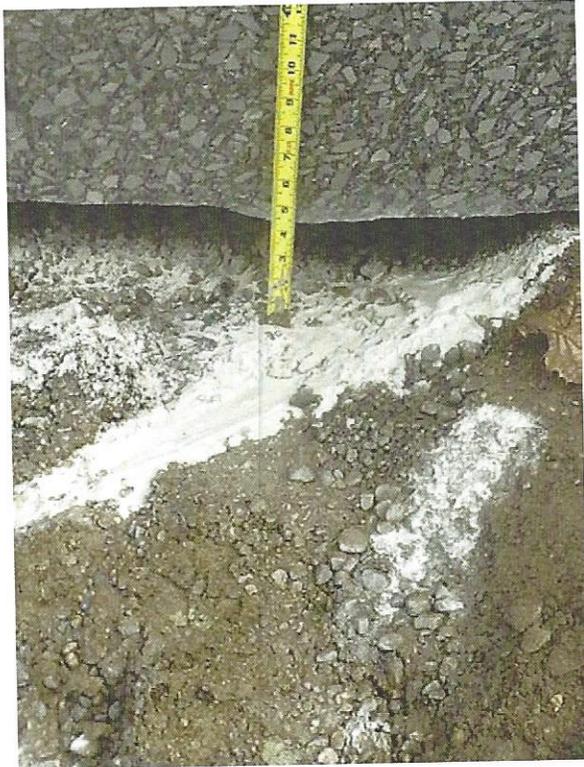
Hole 4 was located at the southern downstream portion of the spillway. This was an area known to have a void based on the Earth Exploration Ground Penetrating Radar (GPR) survey completed in 2015. The investigation observed the void to be 4 inches. The void was located directly adjacent to a drain pipe. The drain pipe was rusty, but in reasonable condition. It was noted that the drain outlet located approximately 20 feet away contained significant fine and course aggregate that was also observed to be in the hole.

Investigation Hole #4
4 inch void (note aggregate material under concrete)

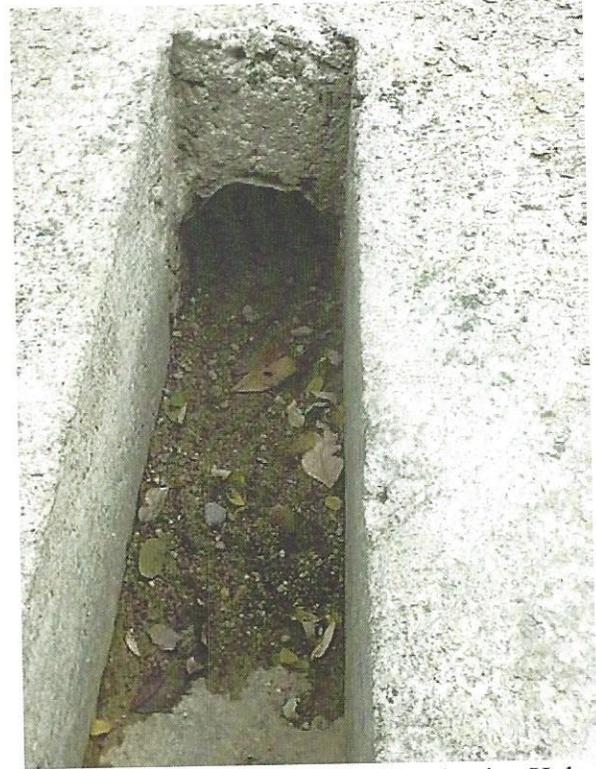
Outlet of adjacent drain pipe for Investigation Hole #4
(note deposited material similar to that observed within hole)

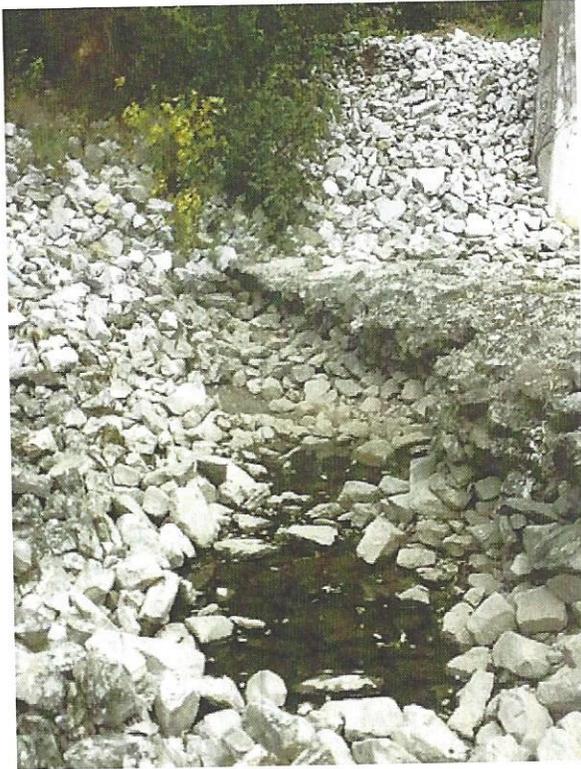
Noted Riprap Displacement
Needs filled

A visual inspection of the drawdown conduit was completed. No items of concern were noted. Additionally, some riprap displacement was observed downstream of the stilling basin. It is recommended additional riprap be placed to fill the holes observed. Lastly, a 40 foot section of floor upward displacement was noted along the northern side of the basin. This was noted in the lower half approximately 10 feet from the side wall. It is believed this uplift is related to settlement of the middle portion of the spillway at this location.

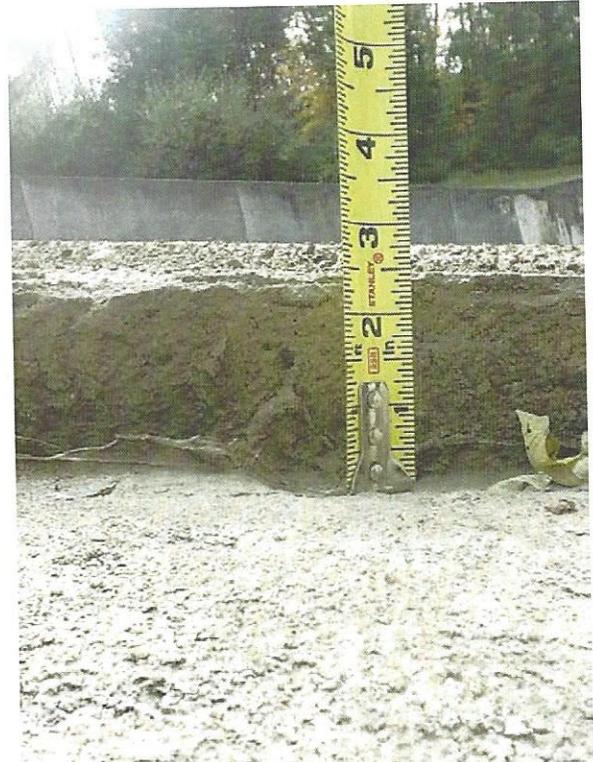
Uplift noted along North Side of Spillway
